Coil engine performances

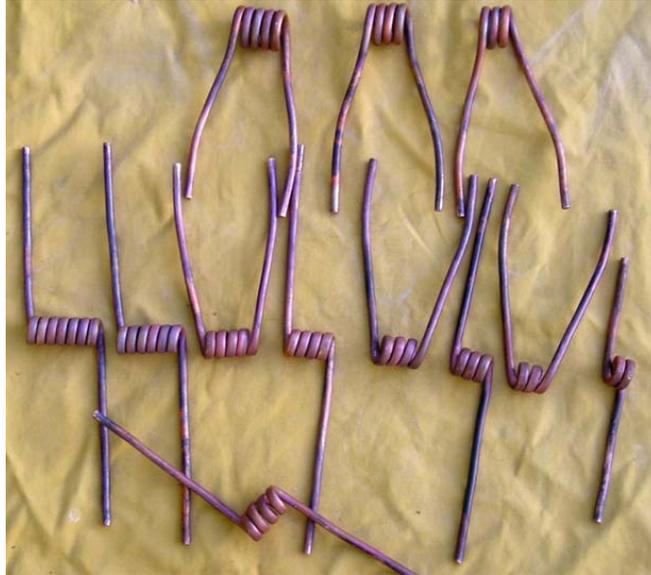
The three engines on the top of the picture have a bigger coil diameter than the others.

The one at the bottom is theoretically identical to the one in the middle, but we built a new one when we encountered a problem described further.

For a more exhaustive testing we built some engines with opposite pipes. Obviously, it is only for test purpose. It wouldn't be realistic on a boat.

The engine on the right is shorter than the others, but it has been connected to the test bench with a longer nozzle to compensate.

To build these engines we used copper pipe 6x1. For annealing the pipe was heated to become dark red or slightly more (cherry red) and then we let it cool down gently. Then we used a cylindrical piece of metal to roll the pipe around. You can find how to do this on several web sites.

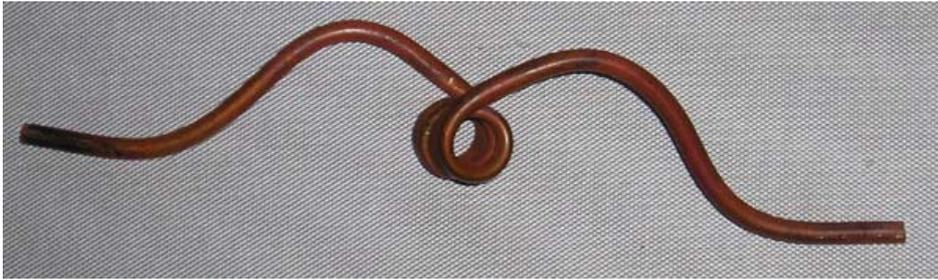
Later with the engine visible on the picture we measured a mean thrust of 12 mN (on each pipe) with peaks up to 18 for half a second. And this time, we could reproduce the result. A short record of this mean thrust is given above with the green curve. For more details look at the document “Test of a coil engine”.
